Goderich Recovery

The following are examples of some of the more obvious restorations or replacements of the Goderich building stock damaged in the Aug 21, 2011 tornado.

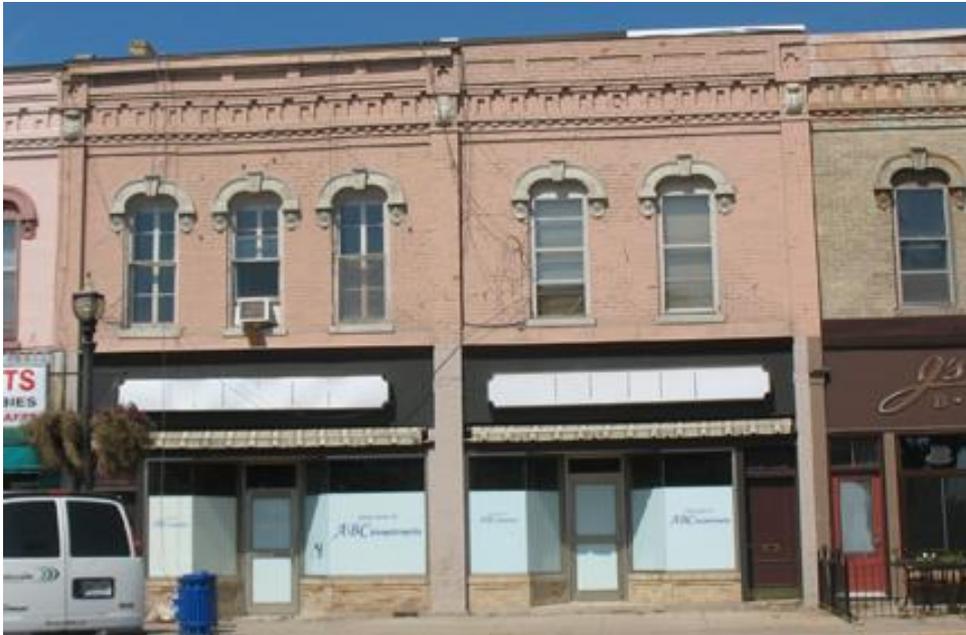
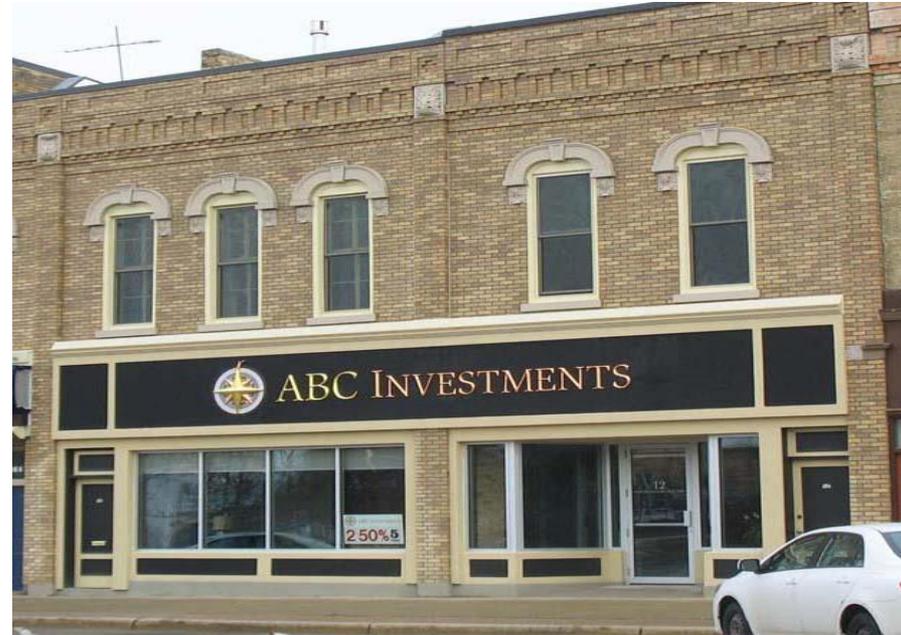
12-14 Courthouse Square

When removing the paint from the façade proved impossible due to brick disintegration, the owners replicated the brickwork and stone accents.

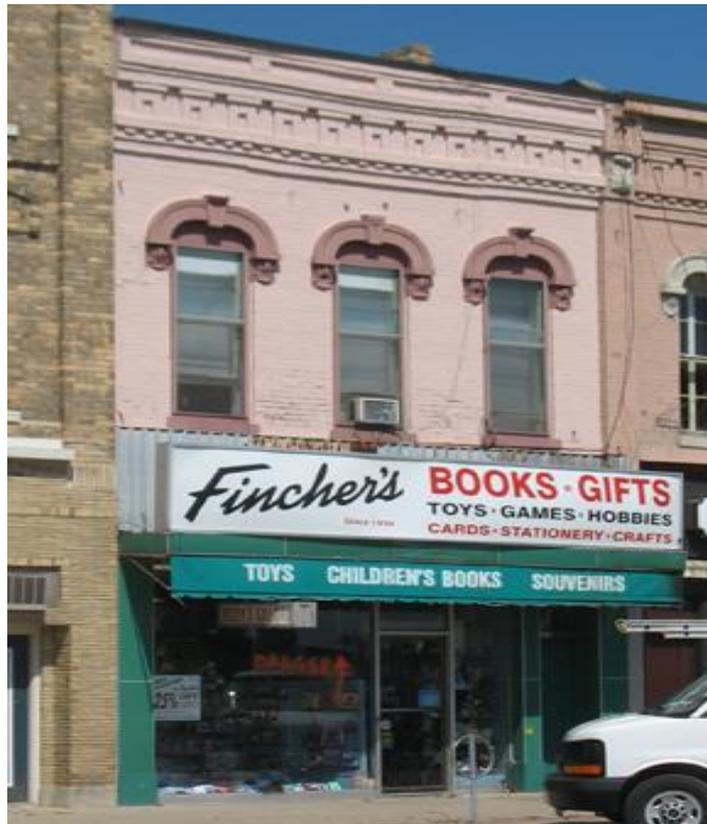
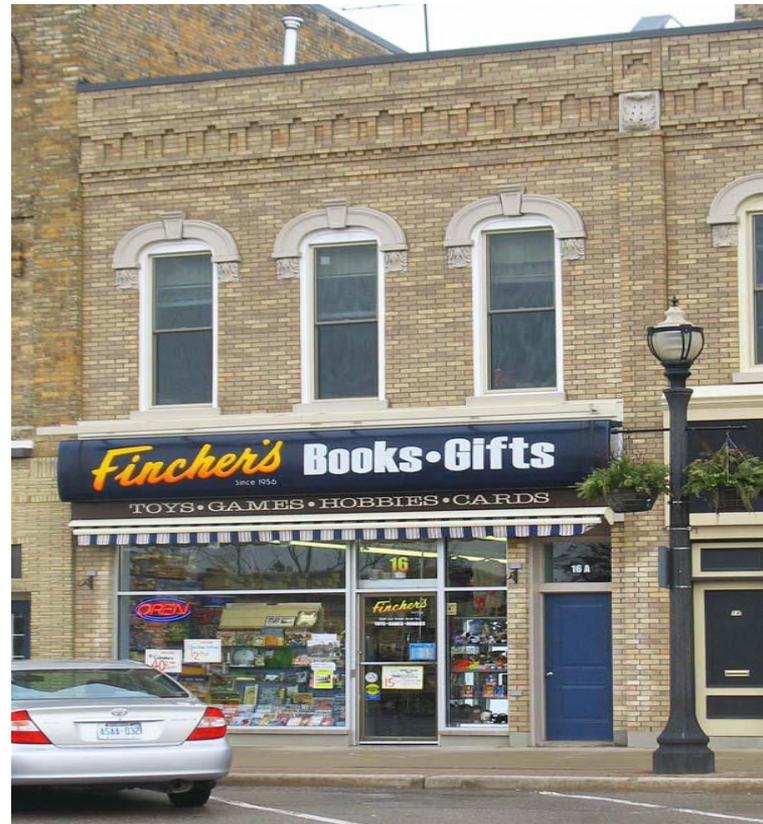
16 Courthouse Square

The neighboring façade improvements encouraged this owner to match the work

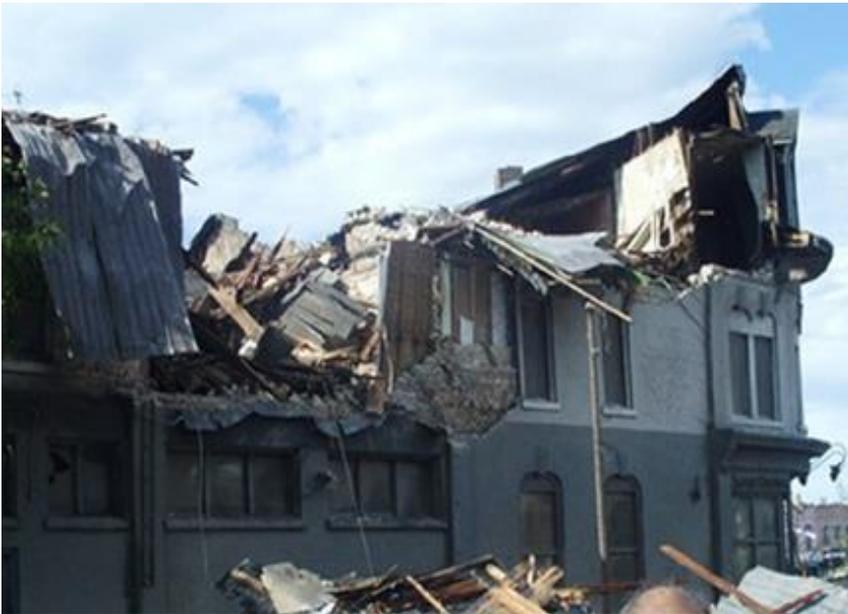
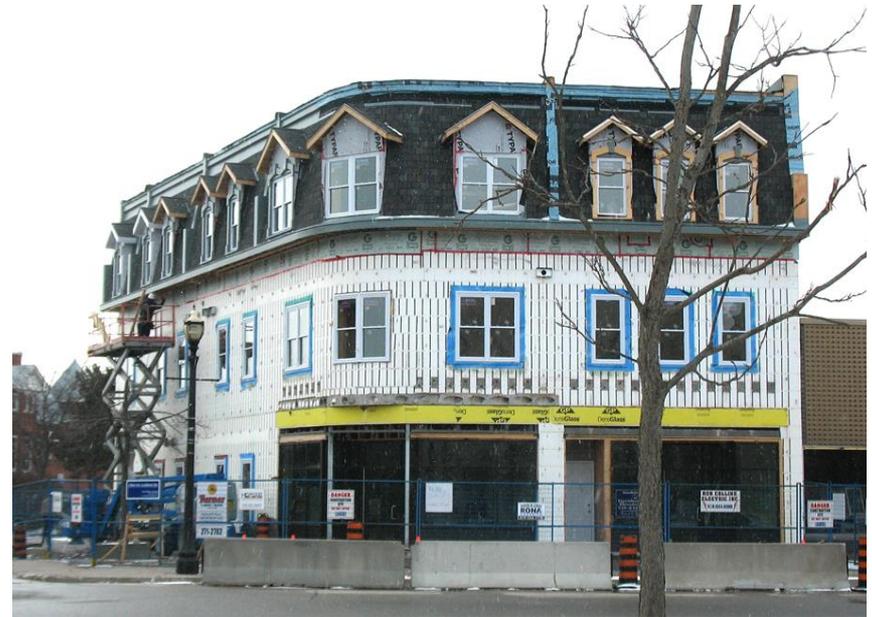
56-58 Courthouse Square:

This iconic Second Empire gem required demolition but the owner chose to rebuild and replicate the building. The reincarnation includes a full third storey where before it was mostly attic space. Eight new apartments and an elevator increase the economic viability of the property.

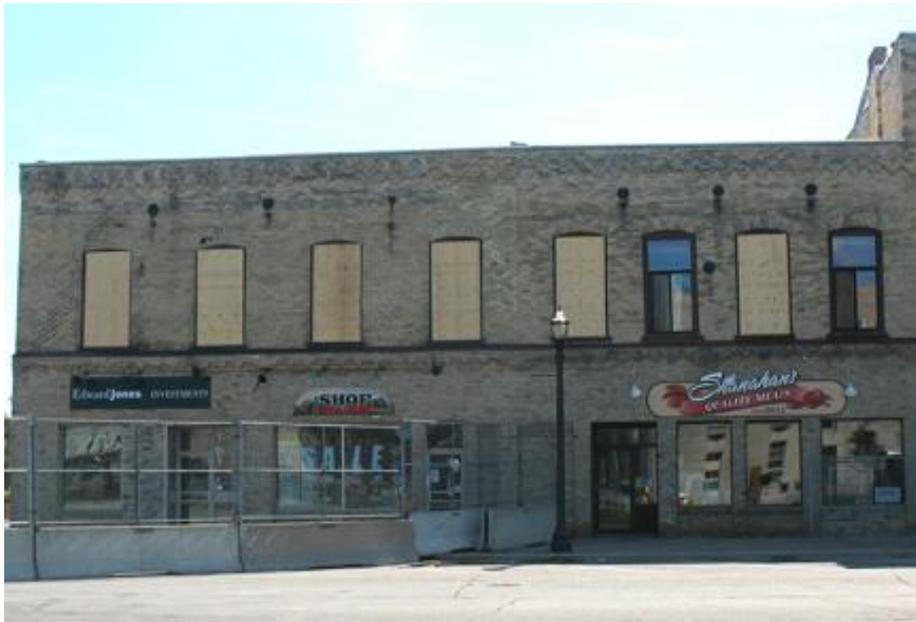
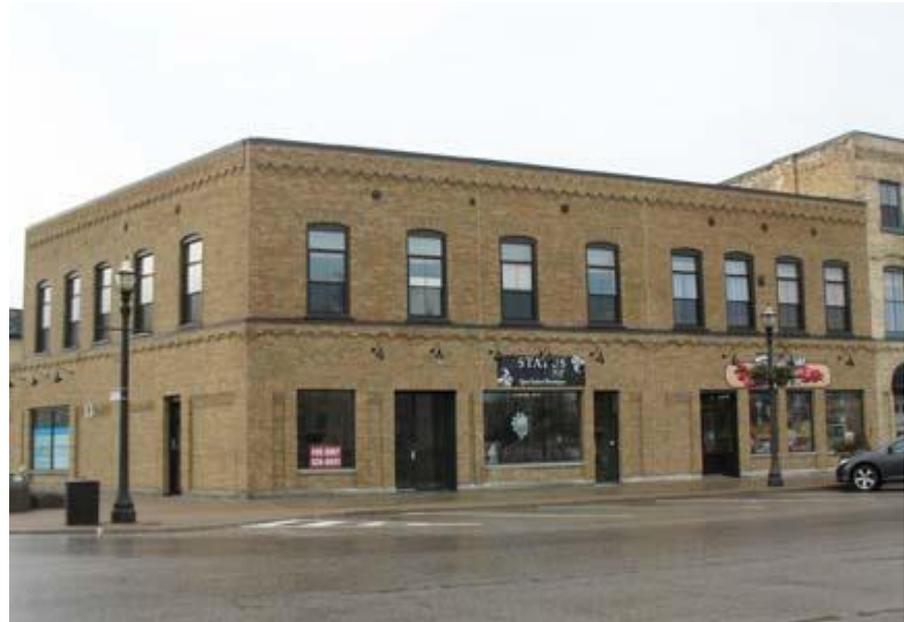
104-108 Courthouse Square

Complete re-bricking of both street facades replicated the existing brick patterns of this corner building.

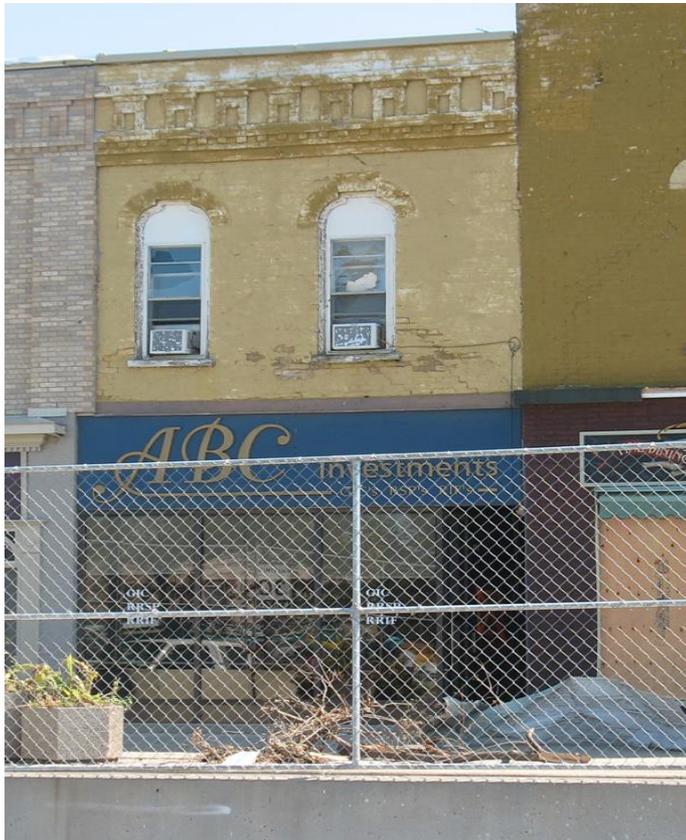
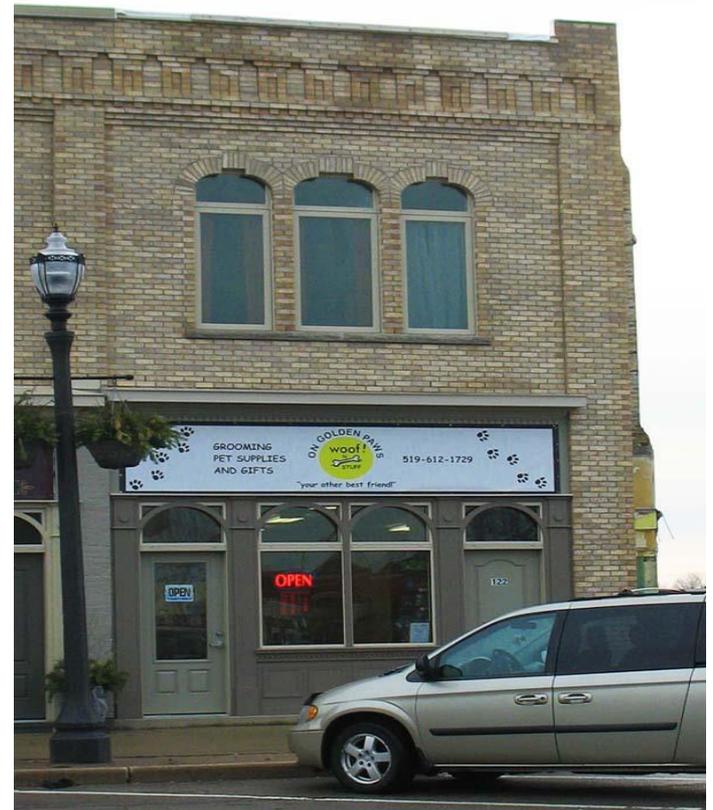
122 Courthouse Square

Extensive structural work was needed to save this building. The façade was redesigned to match the pre-tornado renovations done by the neighboring owners.

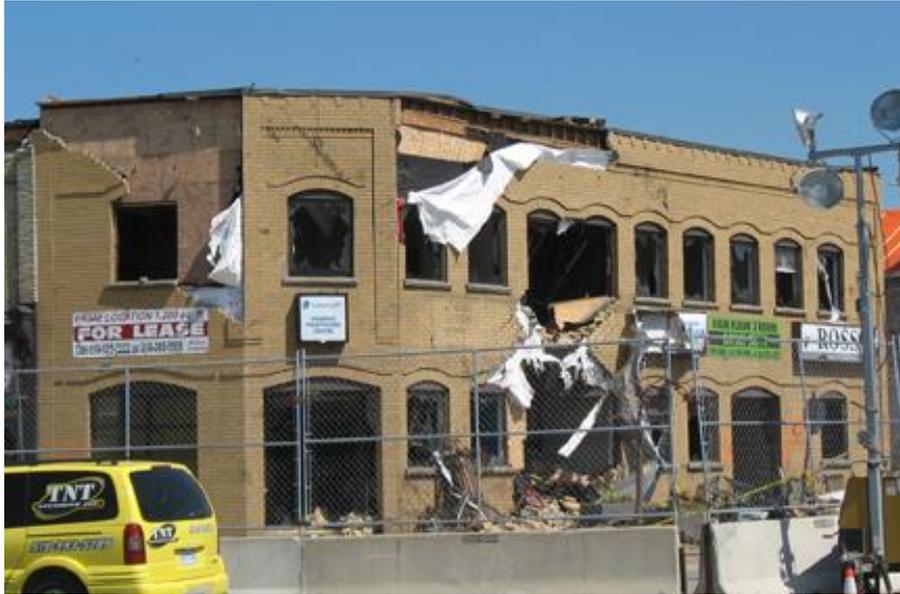
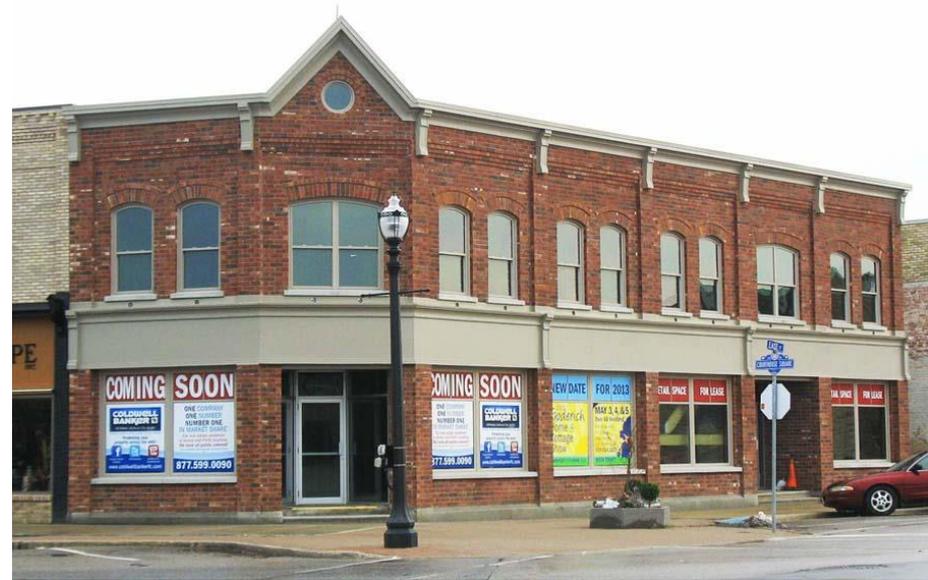
138 Courthouse Square

The damage to the previous 1980s structure dictated demolition. The new building rose from the remaining foundation with an Italianate design somewhat reflective of an even older building.

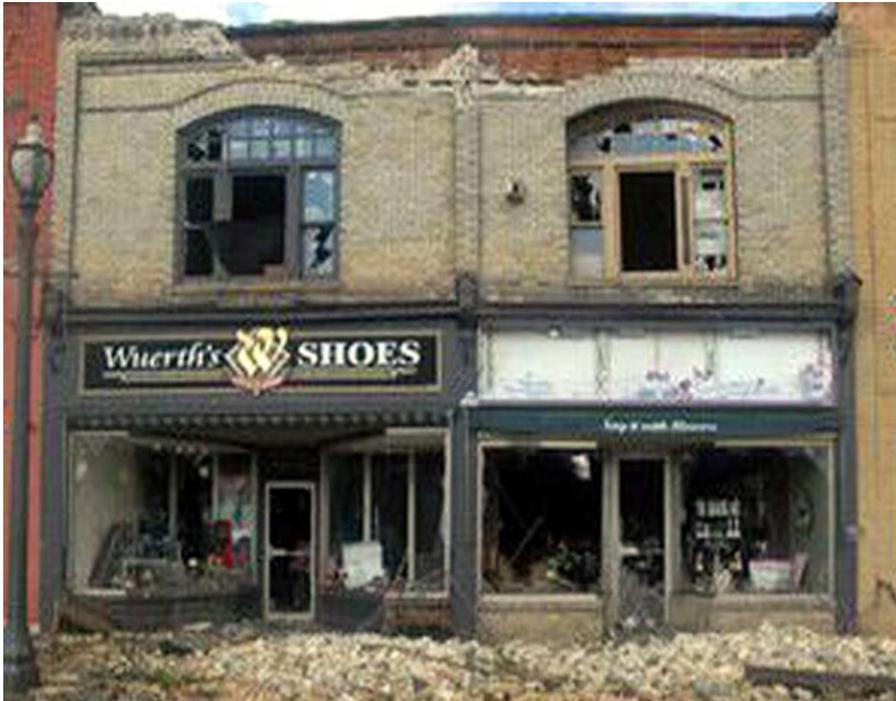
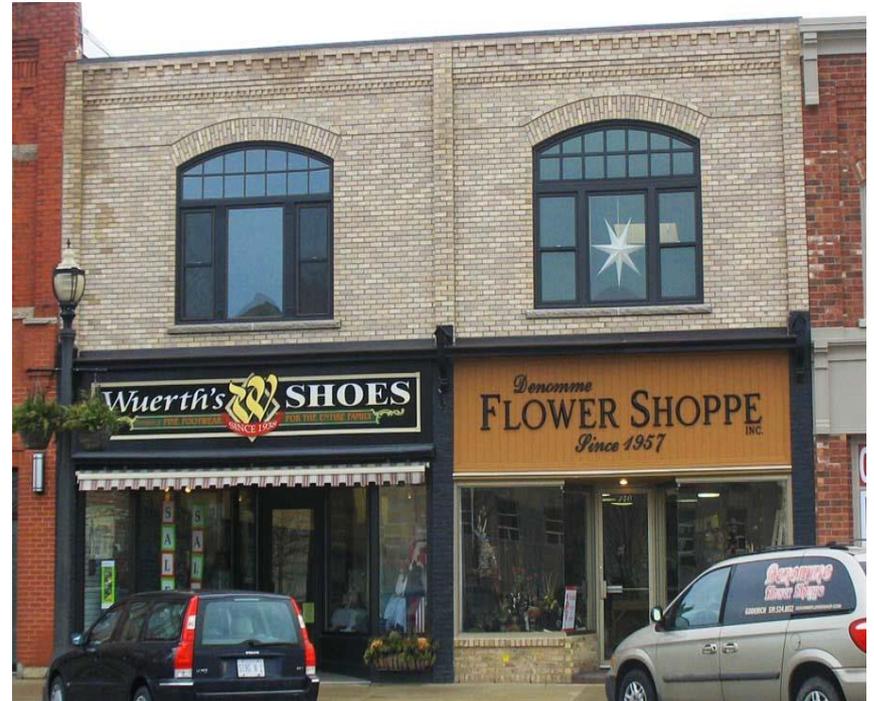
140-142 Courthouse Square

Tornado damage necessitated the removal of the upper façade. Brickwork and window styles were replicated.

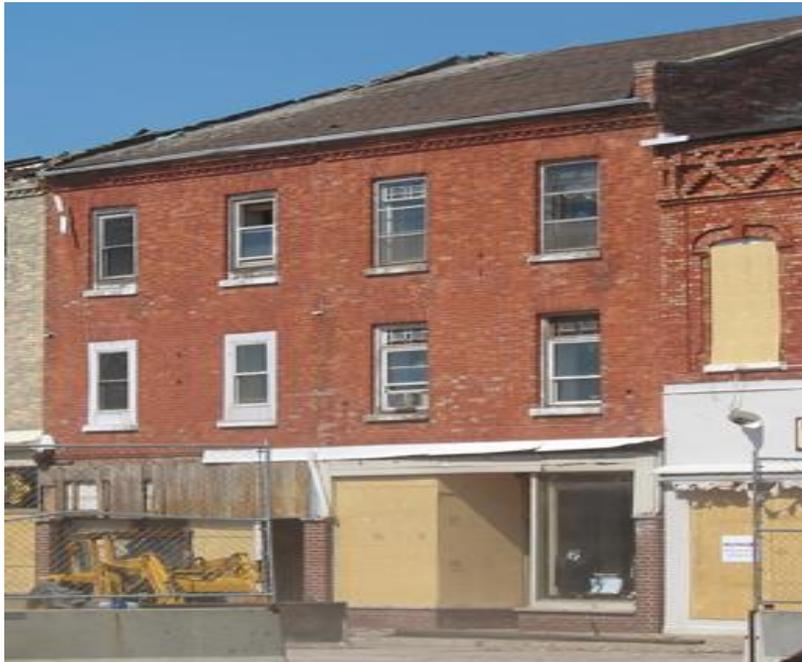
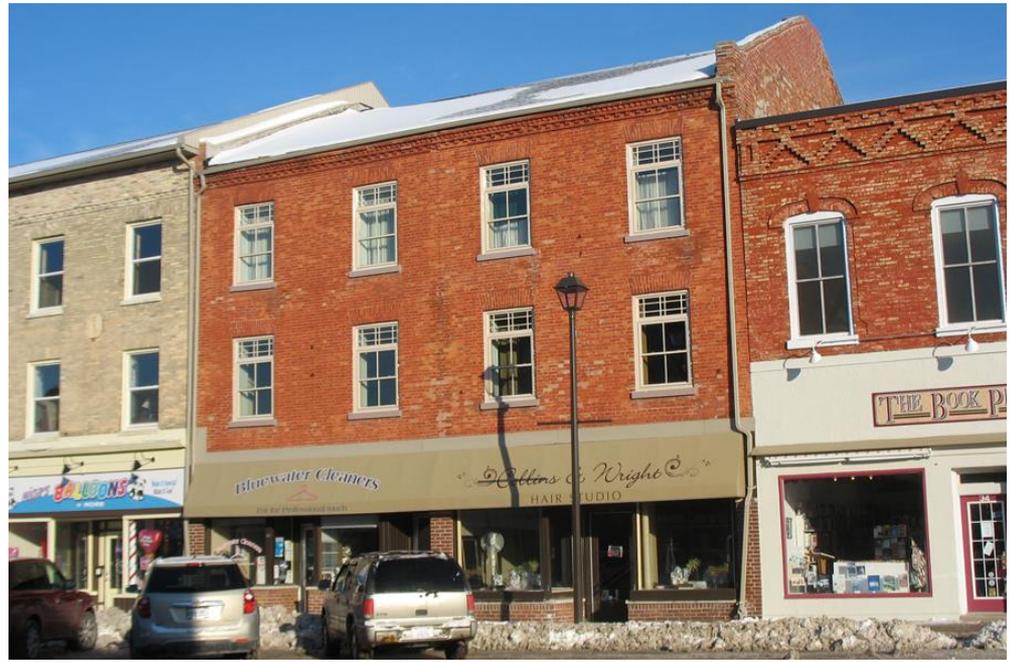
36-38 West Street

Beyond repairing the tornado damage, the owner decided to invest in replacement windows designed specifically with the historic windows in mind.

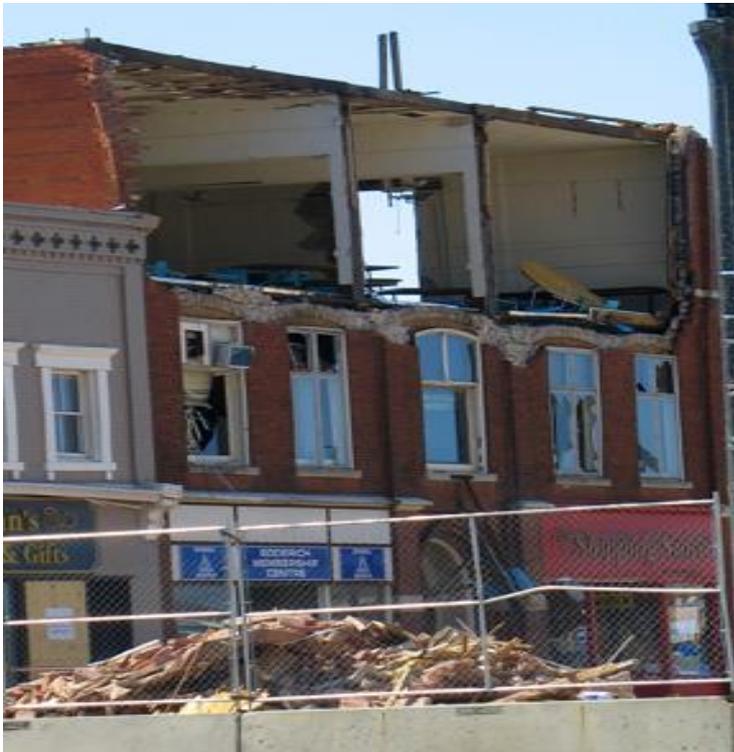
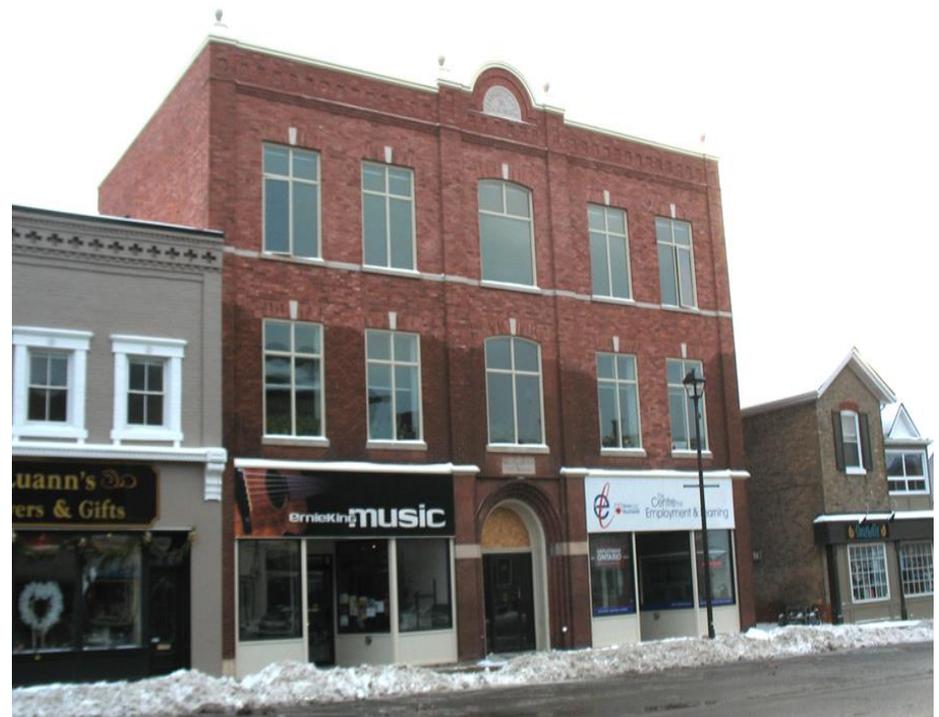
37-41 West Street

Reconstruction included the replacement of the third floor façade using many of the original bricks; replication of the destroyed date stone, stone parapet ornaments and stone string course; rebuilding the roof; and replacing the windows to original configurations.

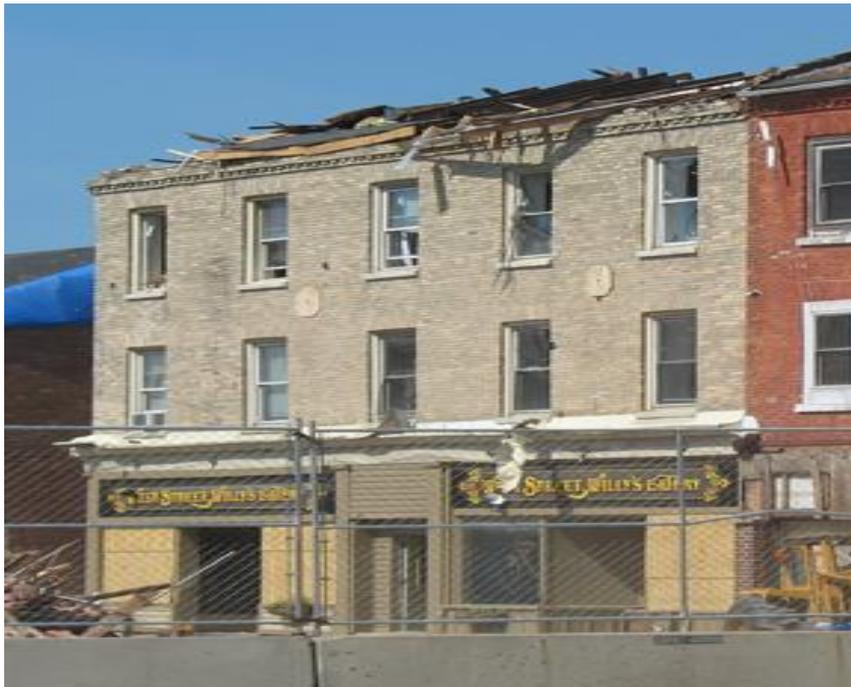
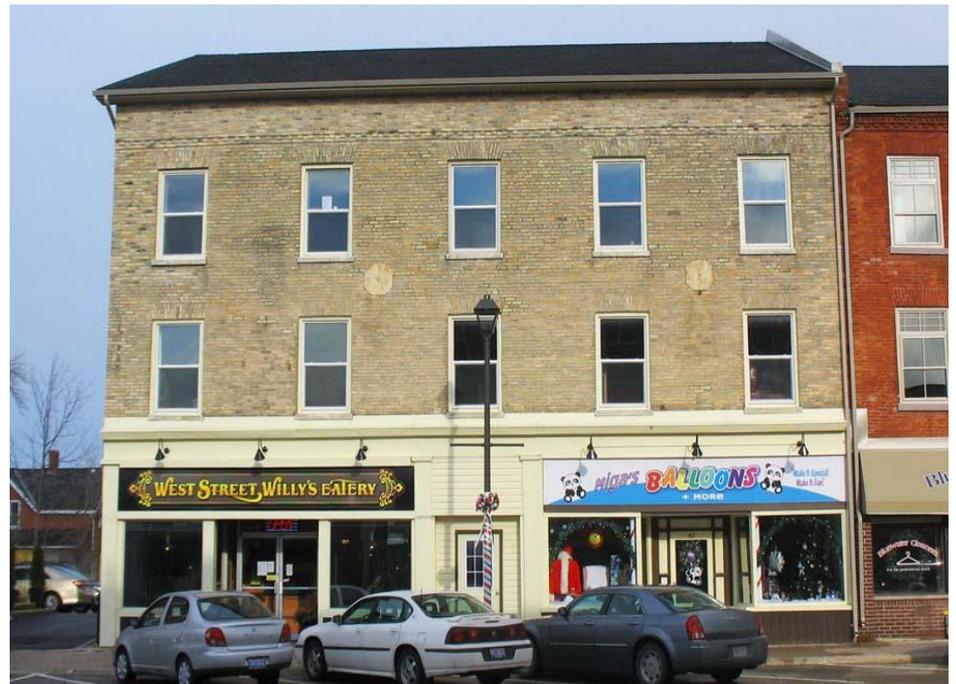
40-42 West Street

Initial damage to the roof and third floor became more extensive after rain in the week following the tornado. This necessitated the complete re-furbishing of all units on all three floors.

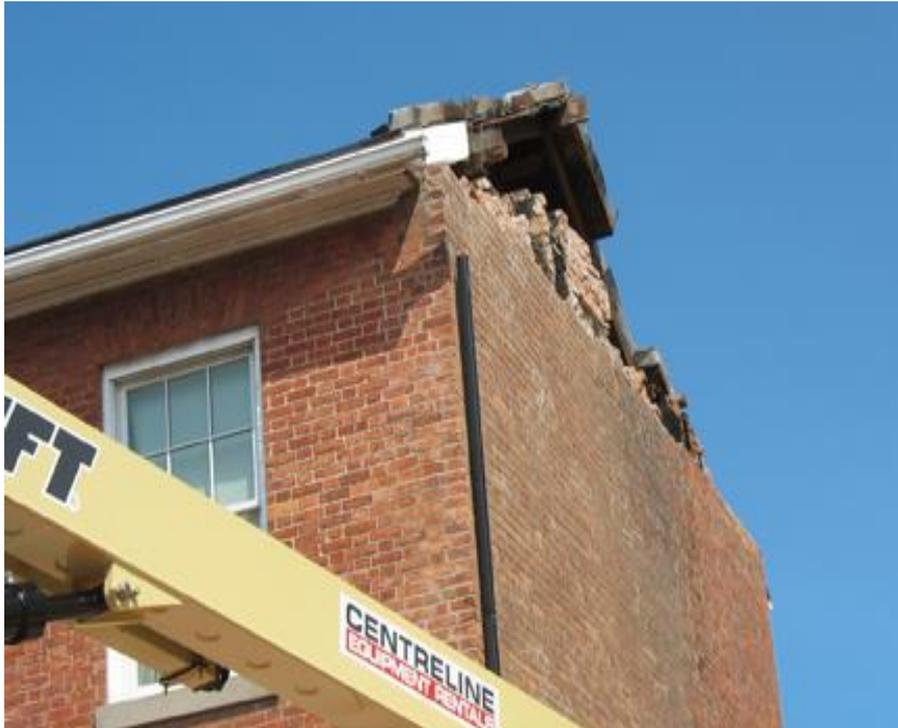
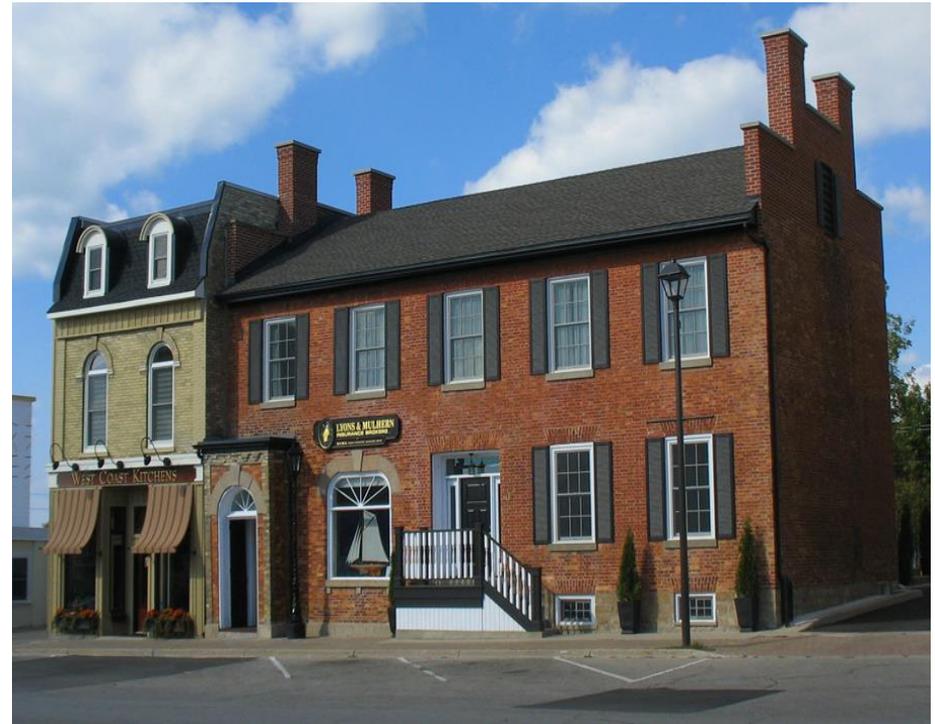
46 West Street

Initially the most obvious damage was to the roof and east wall where the parapet and chimneys were down. Later water damage resulted in the need for a complete interior refurbishing and restoration of this previously-restored, historically-accurate, Georgian building.

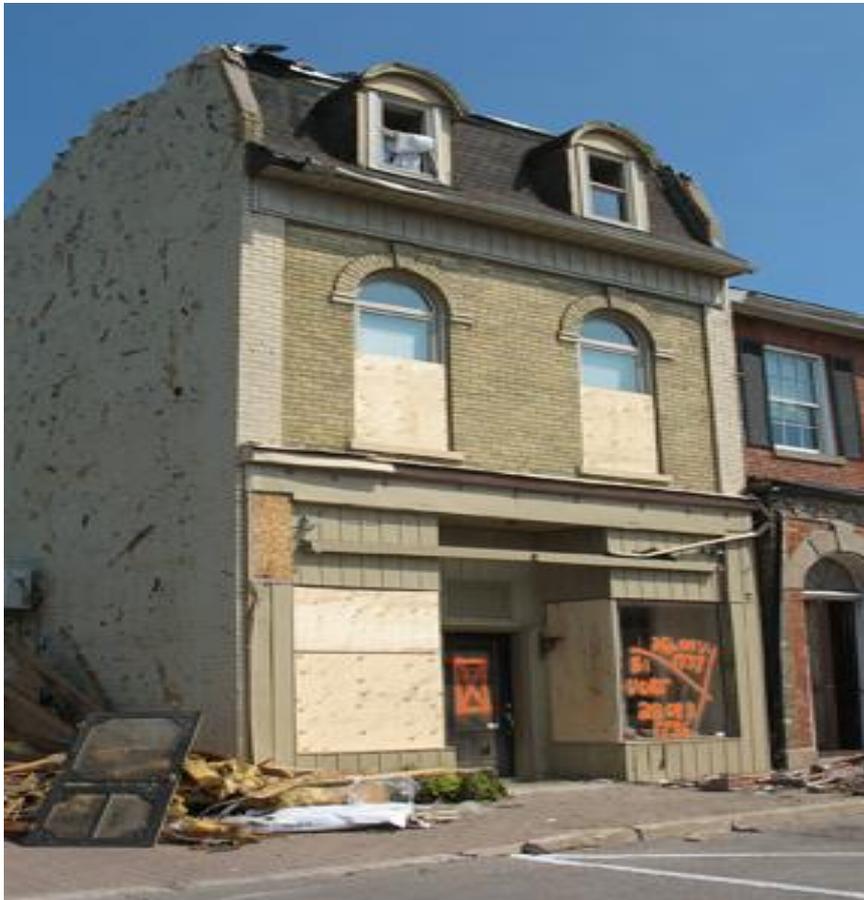
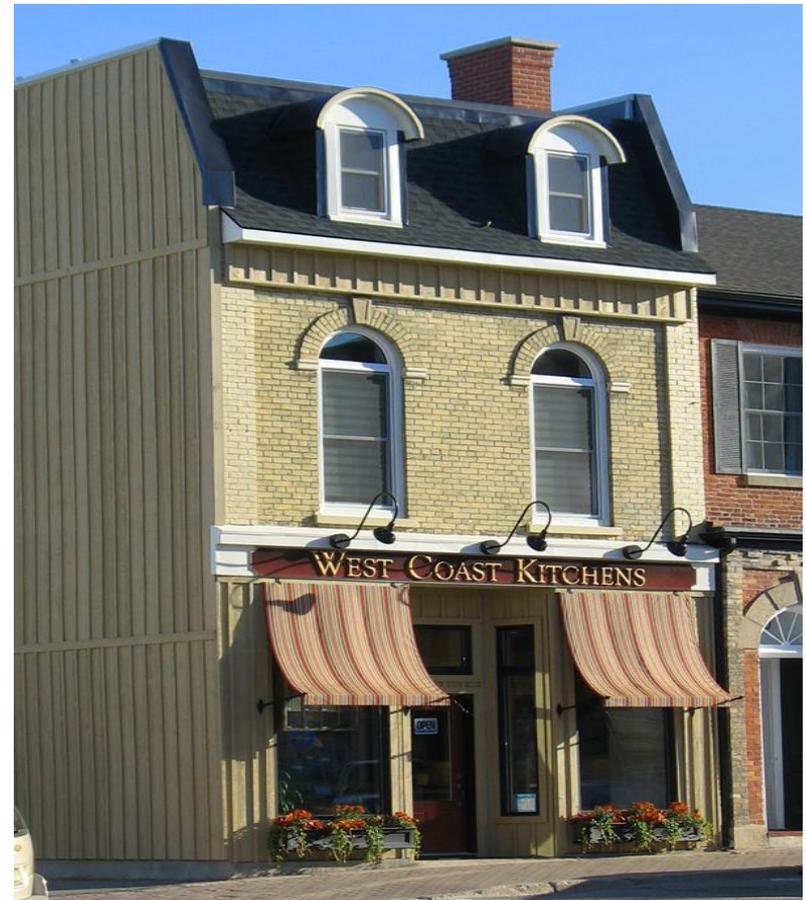
50 West Street

Top to bottom restoration was required in this previously-restored Second Empire building.

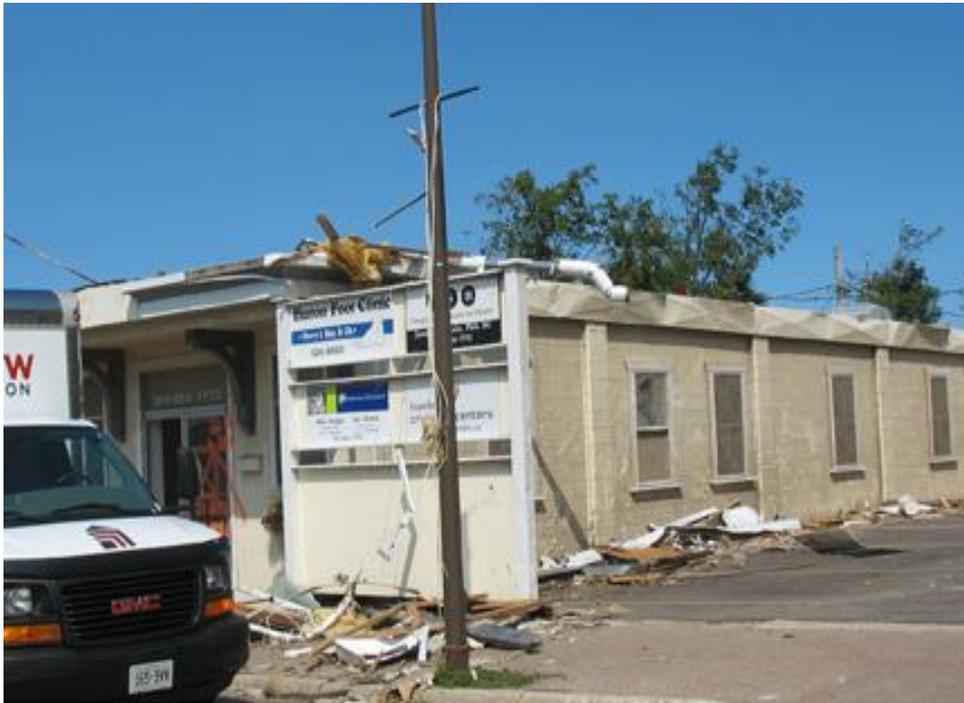
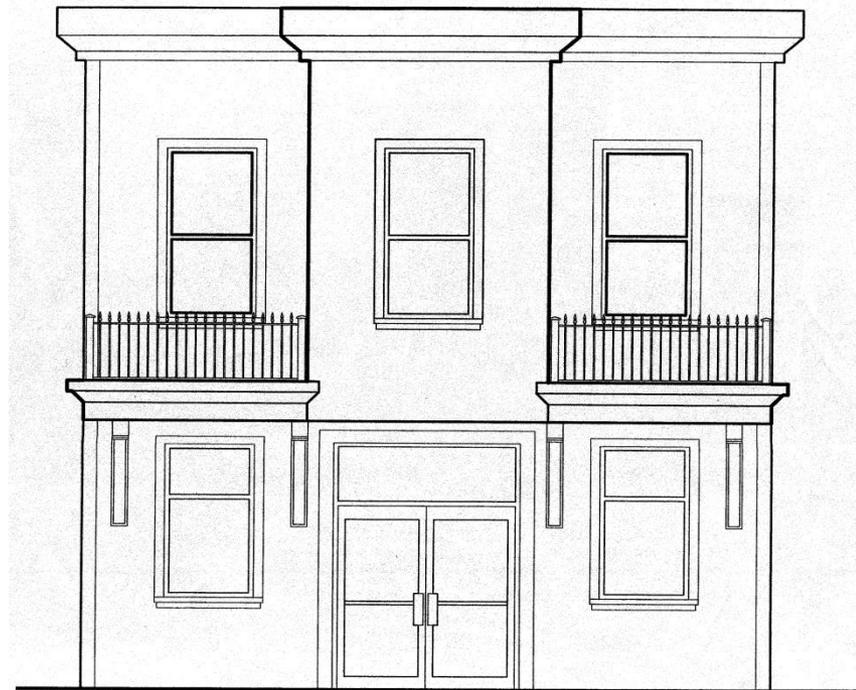
54 West Street

This former Laundromat had been successfully renovated into small offices. The owners have decided to go beyond repair and create a second storey in an historically appropriate design. This will complete the two-storey streetscape in this part of the district.

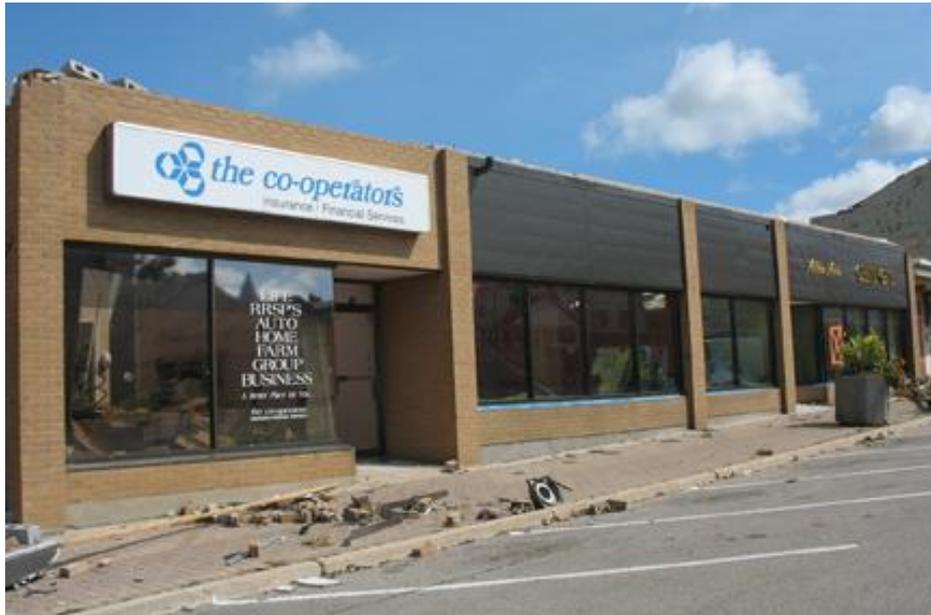
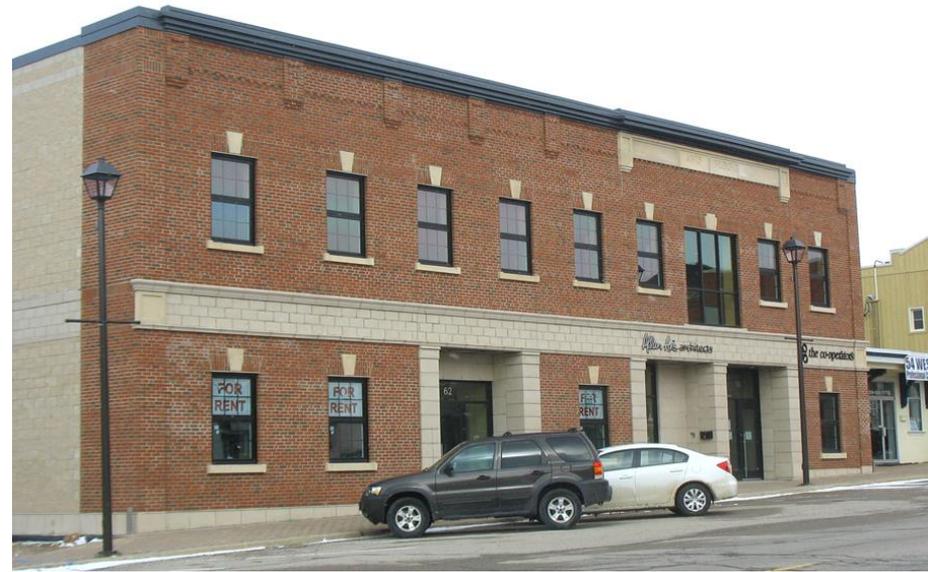
56-60 West Street

The former one-storey, newly renovated architect's office lost its roof and most walls. Rebuilding met the planning requirement calling for two-storey replacement buildings in heritage districts. This Georgian-inspired building and its neighbour now give a substantial presence to this end of the block, totally in keeping with the historic buildings

farther along the street.

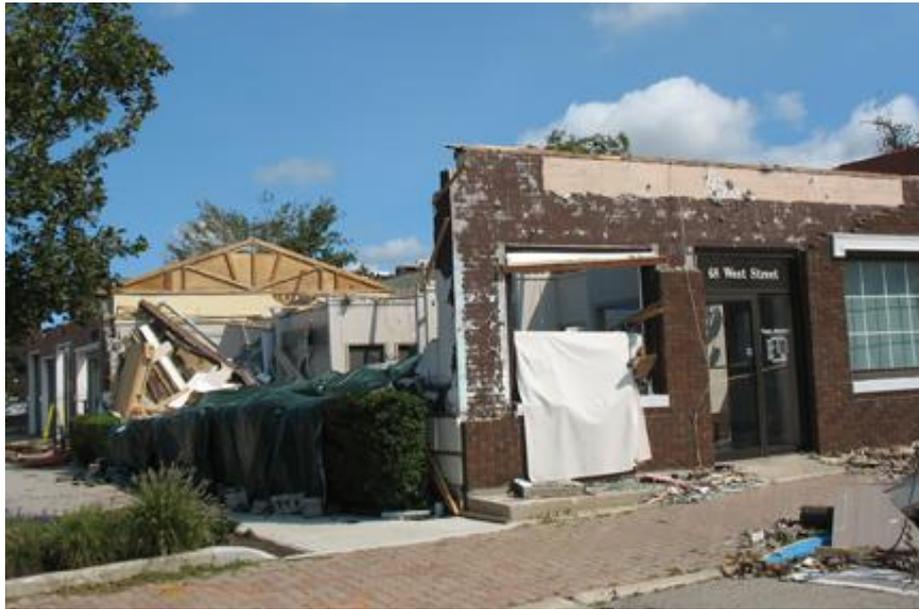
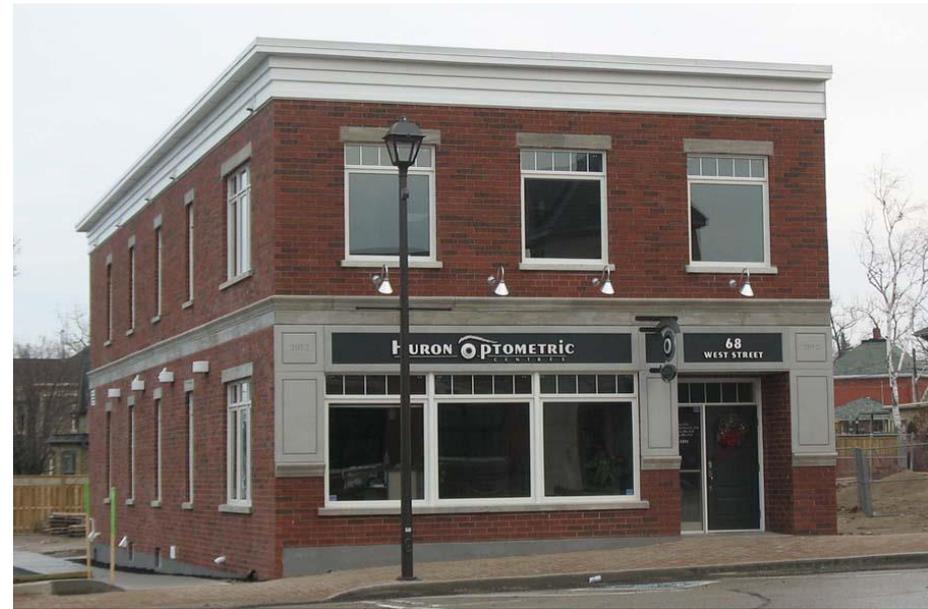
68 West Street

The one-storey corner building was totally destroyed and has been replaced with this Italianate, two-storey structure. Along with its neighbour, this welcome addition helps to anchor the west end of the heritage block.

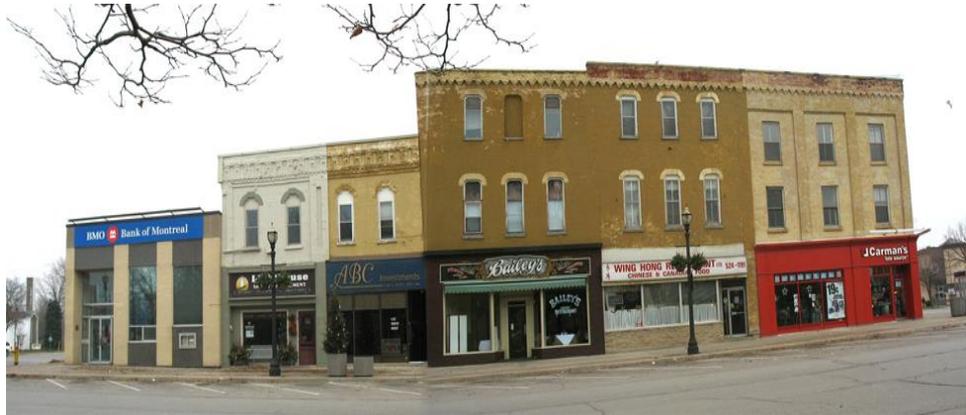
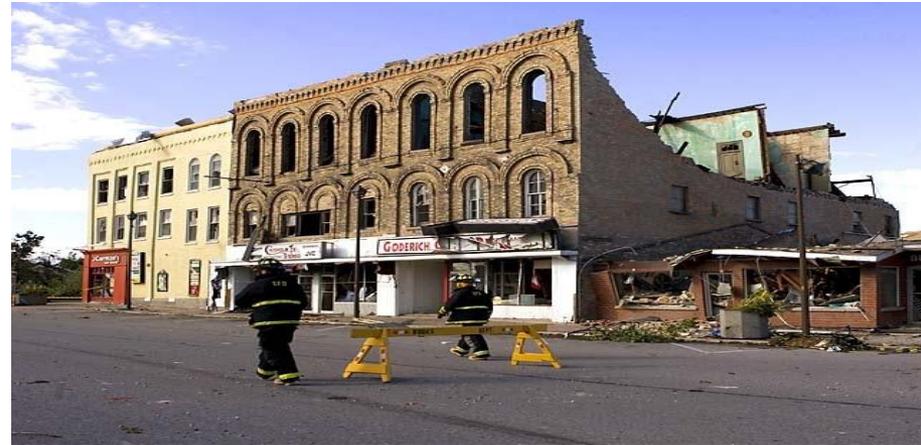
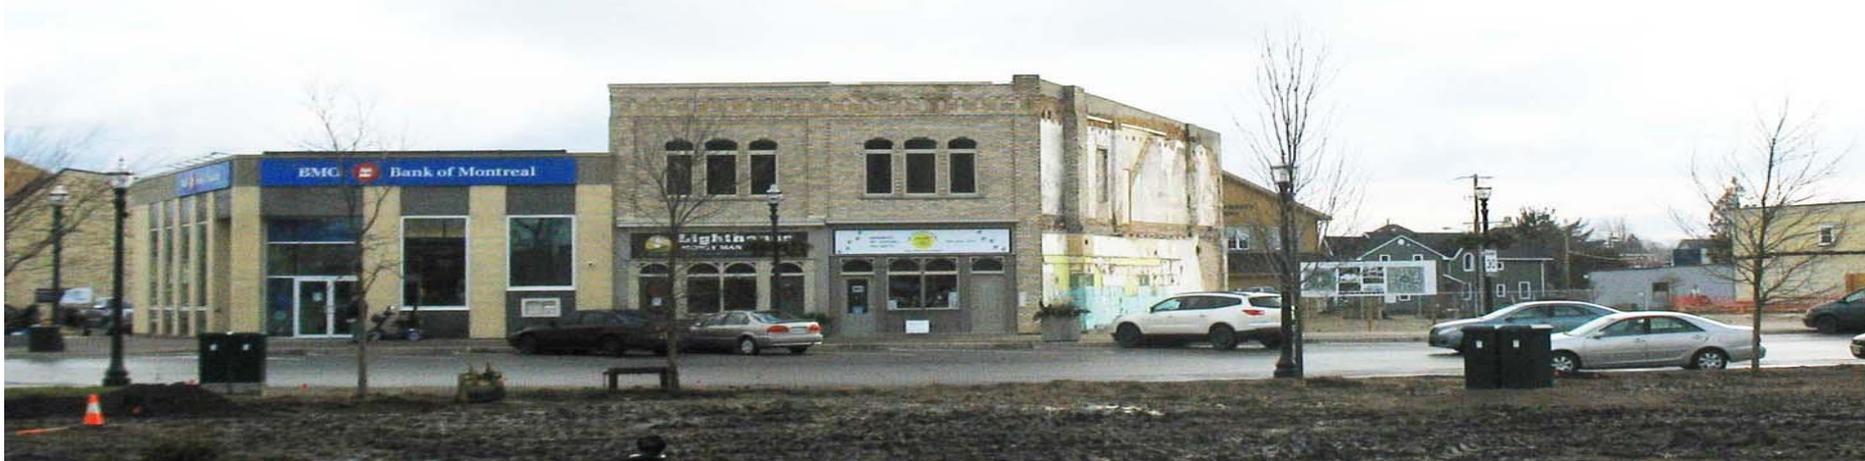
128-112 Courthouse Square
before August 2011

The top photos show the before and after pictures of an entire block hit by the August 2011 tornado.

With some businesses still standing much of the block was destroyed forcing owners to relocate and start from scratch.

The bottom picture shows several properties form a large block of empty land at the corner of Courthouse Square and Kingston Street awaiting recovery from the 2011 tornado.
